Supplemental Service Manual

906-2150-002 Rev. C, TEXT ONLY

***Centurion** Vision System Supplemental Service Manual**

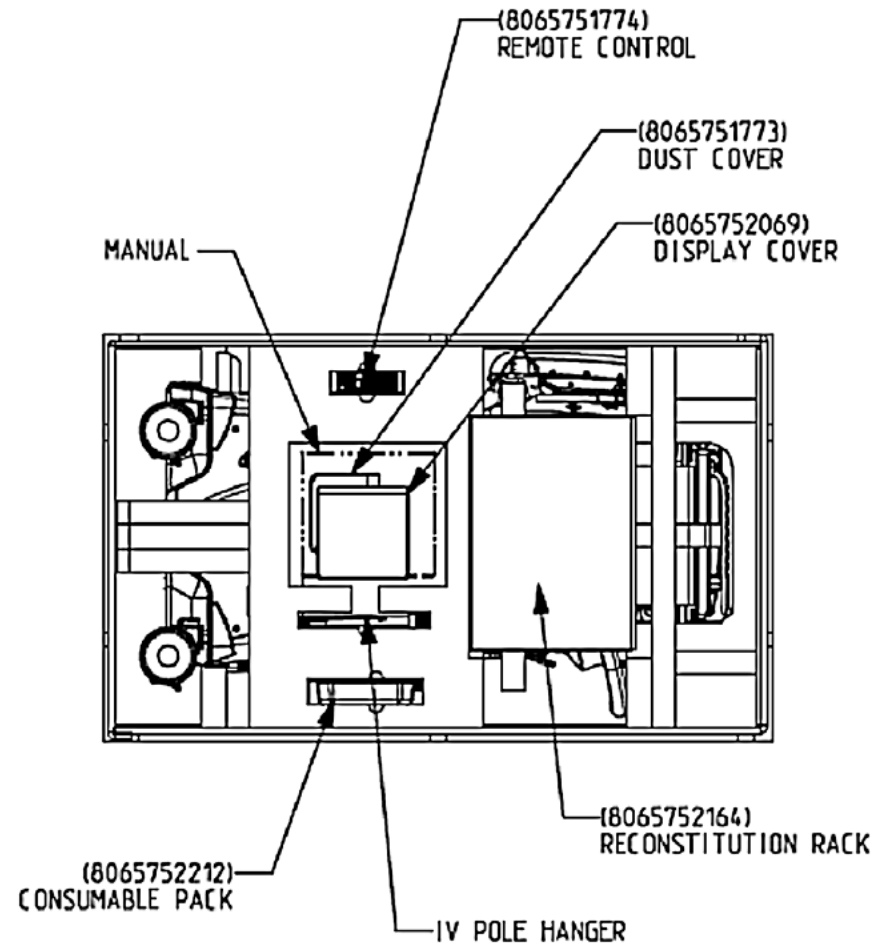
Figure 1-1 Packing Configuration

- 6.1.1 Cut the packing straps and then remove the top cover. Refer to [Figure 1-1](#) for packing configuration.
- 6.1.2 Remove all the accessories and set aside; (operator's manual, dust cover, display cover, remote control, IV pole hanger, cassette pack and reconstitution BSS bag rack)

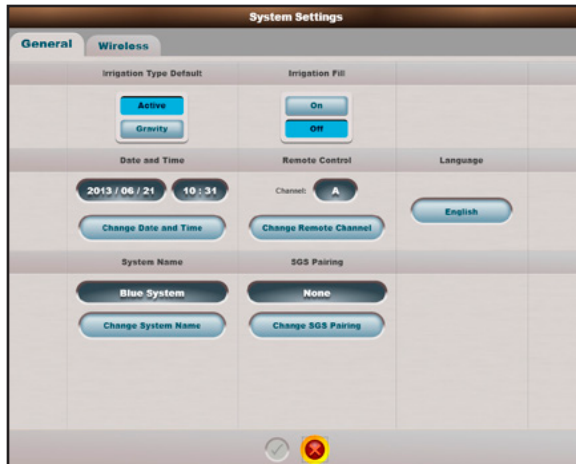
Figure 1-2 System Settings - General Tab for Setting Date and Time (software version 2.03 shown)

- 6.4.1 Plug console into power outlet and turn on.
- 6.4.2 Navigate to *System Settings/General* tab and set the Date & Time (see [Figure 1-2](#)).

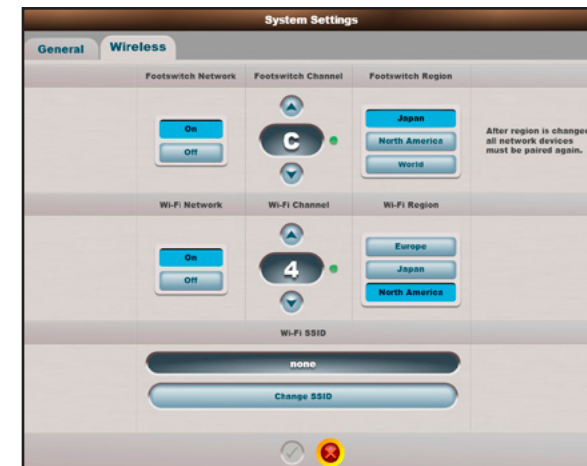
Figure 1-3 System Settings - Wireless Tab for Footswitch Setup (software version 2.03 shown)

- 6.5.1 *For systems with software below version 3.0* - Select the *System Setting/Wireless* tab, then set the wireless footswitch and WiFi settings as necessary. For wireless footswitch, select Japan for Footswitch Region. (see [Figure 1-3](#)).

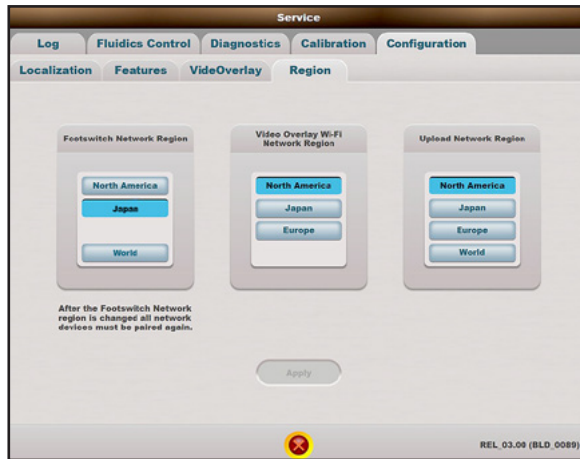
Figure 1-4 Service Screen for Software Version 3.0 - Configuration/Region Tab

- 6.5.2 For systems with software version 3.0 - Go to the *Service Screen* and select the Configuration tab, then the Region tab. Setup the Footswitch Network and Wi-Fi Network Region as necessary (see [Figure 1-4](#)).

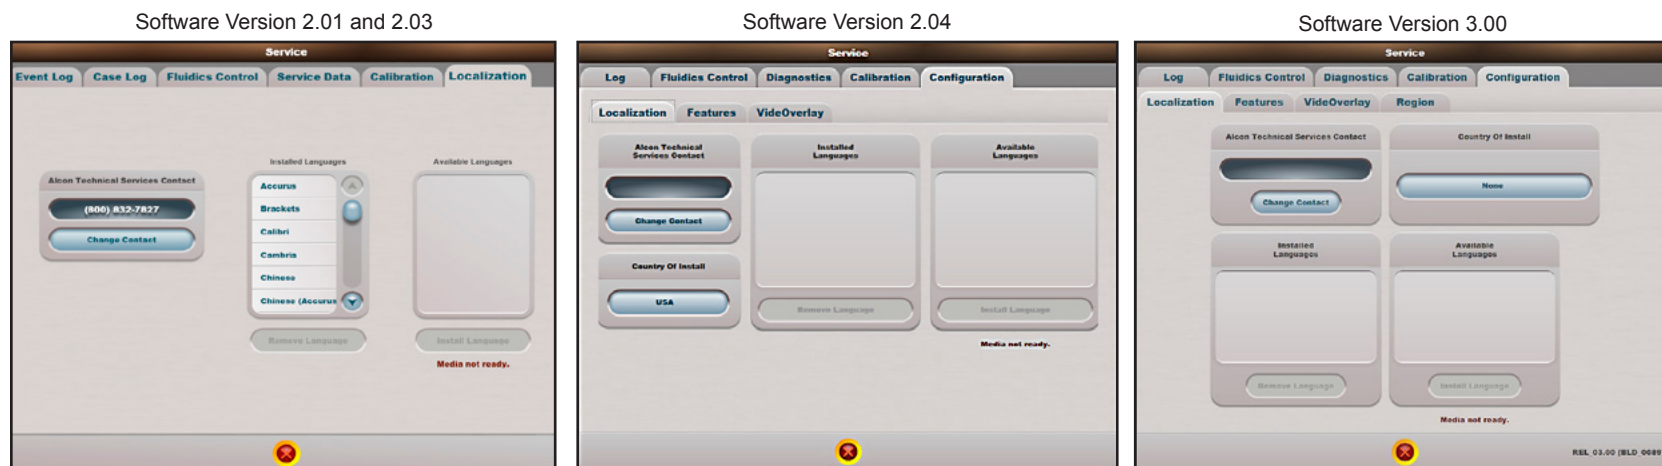
Figure 1-5 Service Screen - Localization Tab for Entering Local Contact Information

- 6.6.1 In the *Service Screen*, select the Localization tab and select *Change Contact*. Enter that country's Technical Services office phone number (see [Figure 1-5](#)).
- 6.6.2 Select country of install.
- 6.6.3 Language installation - Refer to the Language Pack Installation Procedure in the Maintenance section of this document.
- 6.6.4 VideOverlay configuration - Refer to the [VideOverlay Configuration Procedure](#) in the Maintenance section of this document.
- 6.7 Check for Outstanding Service Flash
- 6.7.1 Go to the Service-Flash Online Filing Application (SOFA) and determine if there is an outstanding Service Flash that must be performed on the system.
- 6.7.2 Complete the Service Flash as required or continue to the next step.

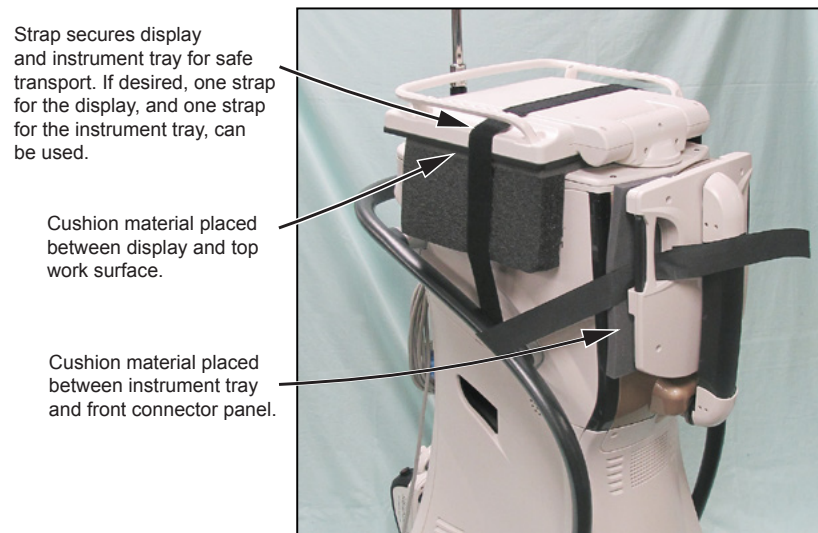
Figure 1-6 Example of Properly Packing the System for Transit

- 7.1 Using the photo shown in [Figure 1-6](#) as an example, secure the display screen and instrument tray as necessary in preparation for transit. **NOTE: Materials from the original shipping container are used in this example.**

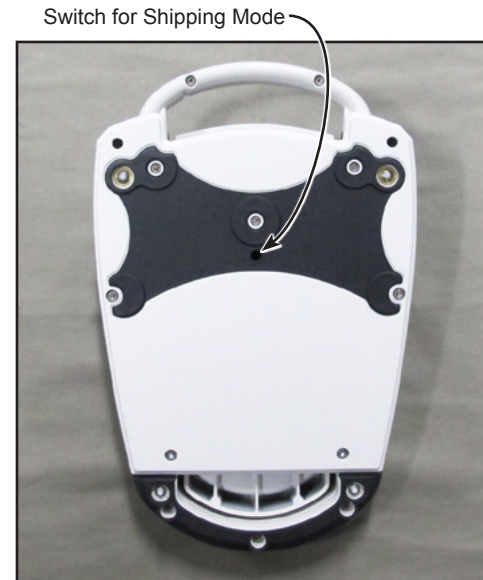
Figure 1-7 Setting the Footswitch to Shipping Mode

- 7.2 Set the footswitch to "shipping" mode by pressing and holding (for at least two seconds) the switch shown in [Figure 1-7](#) with a cotton swab or other instrument that can reach the recessed switch without damaging the rubber covering.

- 7.3 Verify the footswitch is in shipping mode by pressing the treadle down and checking the footswitch LED response. The LED's should not illuminate if the footswitch is in shipping mode.

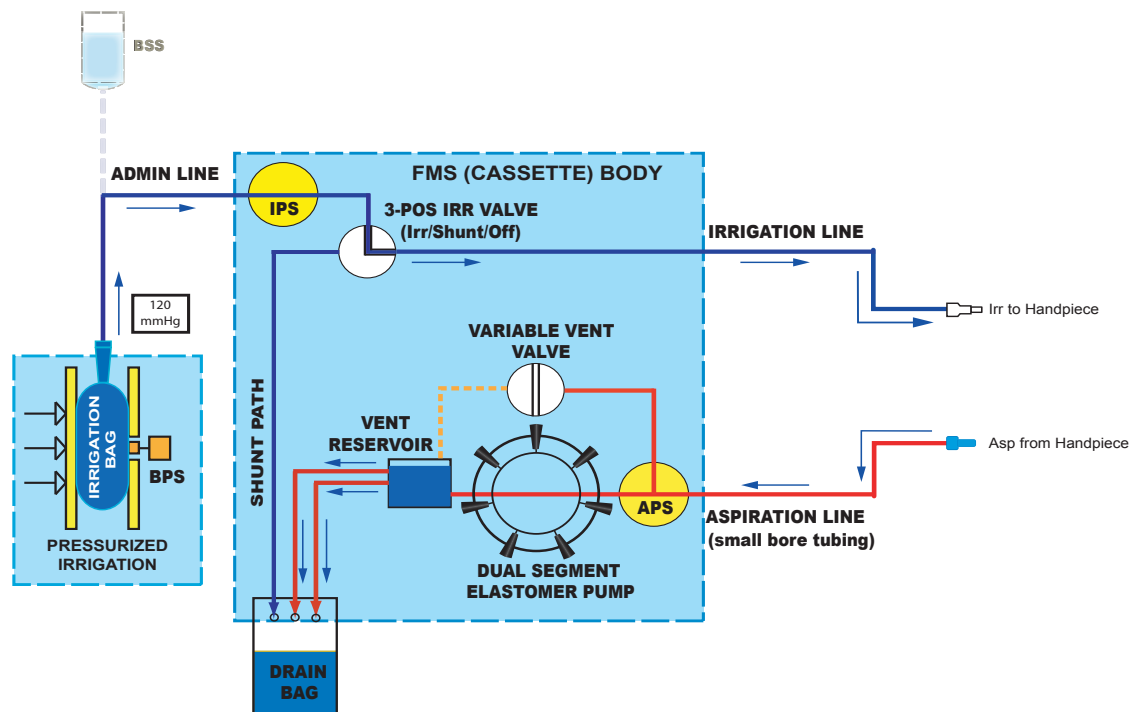
Figure 2-2 Fluidics Fluid Flow Diagram

- 1.7.1 The main function of the Fluidics system is to provide irrigation (active or gravity) and aspiration to the surgical site during a cataract removal procedure. Pressure sensors enable the system to detect an overpressure or underpressure condition relative to a surgeon-selected IOP target setting. Additional control features are provided to allow adjustment to the level of flow compensation based on the surgeon's observations of the anterior chamber fluctuations. This provides flexibility to customize the system to accommodate for differences in surgical technique, incision size, tip/sleeve selection, or surgeon preference. *Figure 2-2* shows a diagram of the fluid flow in the fluidics system.

- 7.2 The *Centurion** Vision System provides for control of fluid into and out of the eye during the surgical procedure. The basic fluid circuit is illustrated in *Figure 2-2* on page 2.3. There are two methods of generating input pressure that are supported by the system; Active Irrigation (AI) and Gravity Irrigation.

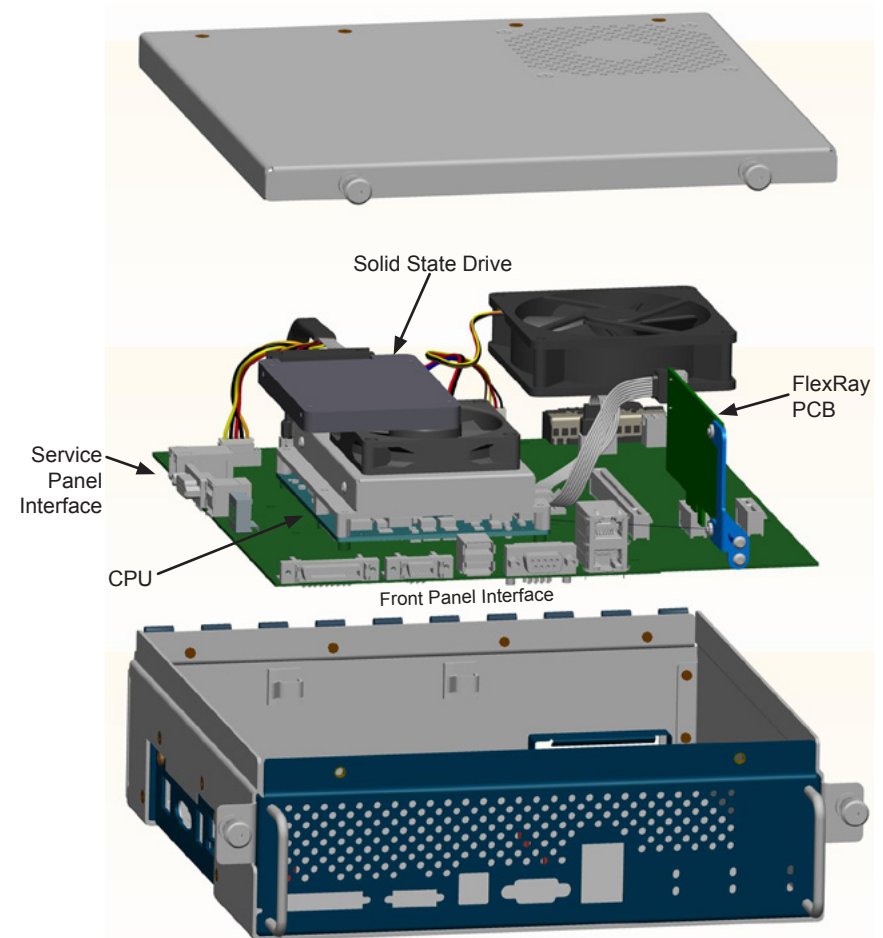
Figure 2-4 Host Module

- 4.1 The Host Module shown in **Figure 2-4** uses a custom COM-Express CPU module to communicate system level controls to subsystem modules through a PCIe FlexRay Controller located inside the host module. In addition it controls the display and processes user input from the touch screen. **Figure 2-5** shows a block diagram the Host module.

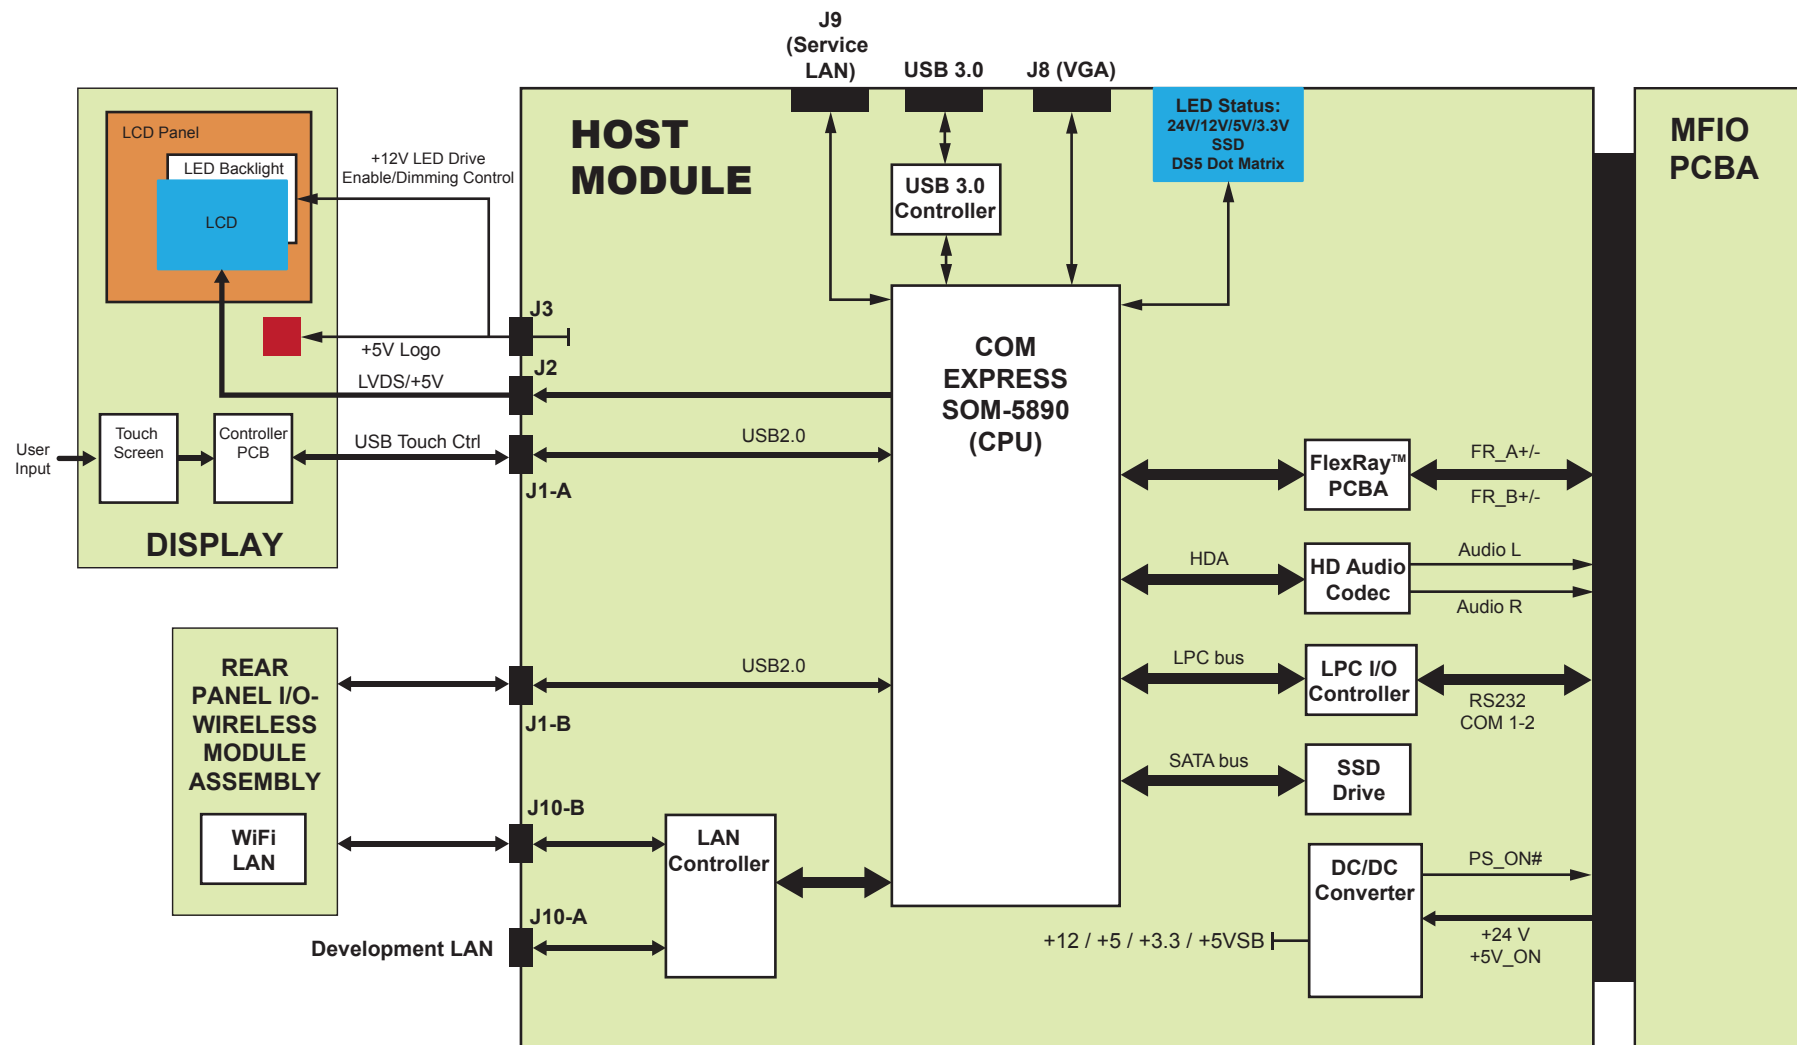
Figure 2-5 Host Module - Display Block Diagram

- 5.1 The Display Module is the primary user interface for the system. The LCD displays the GUI (Graphical User Interface) and the Touch Screen accepts user input. *Figure 2-5* shows the electrical block diagram for the module. The Display Module is mounted to the Front Panel which is designed so that it can be repositioned to accommodate different user positions around the front of the console.

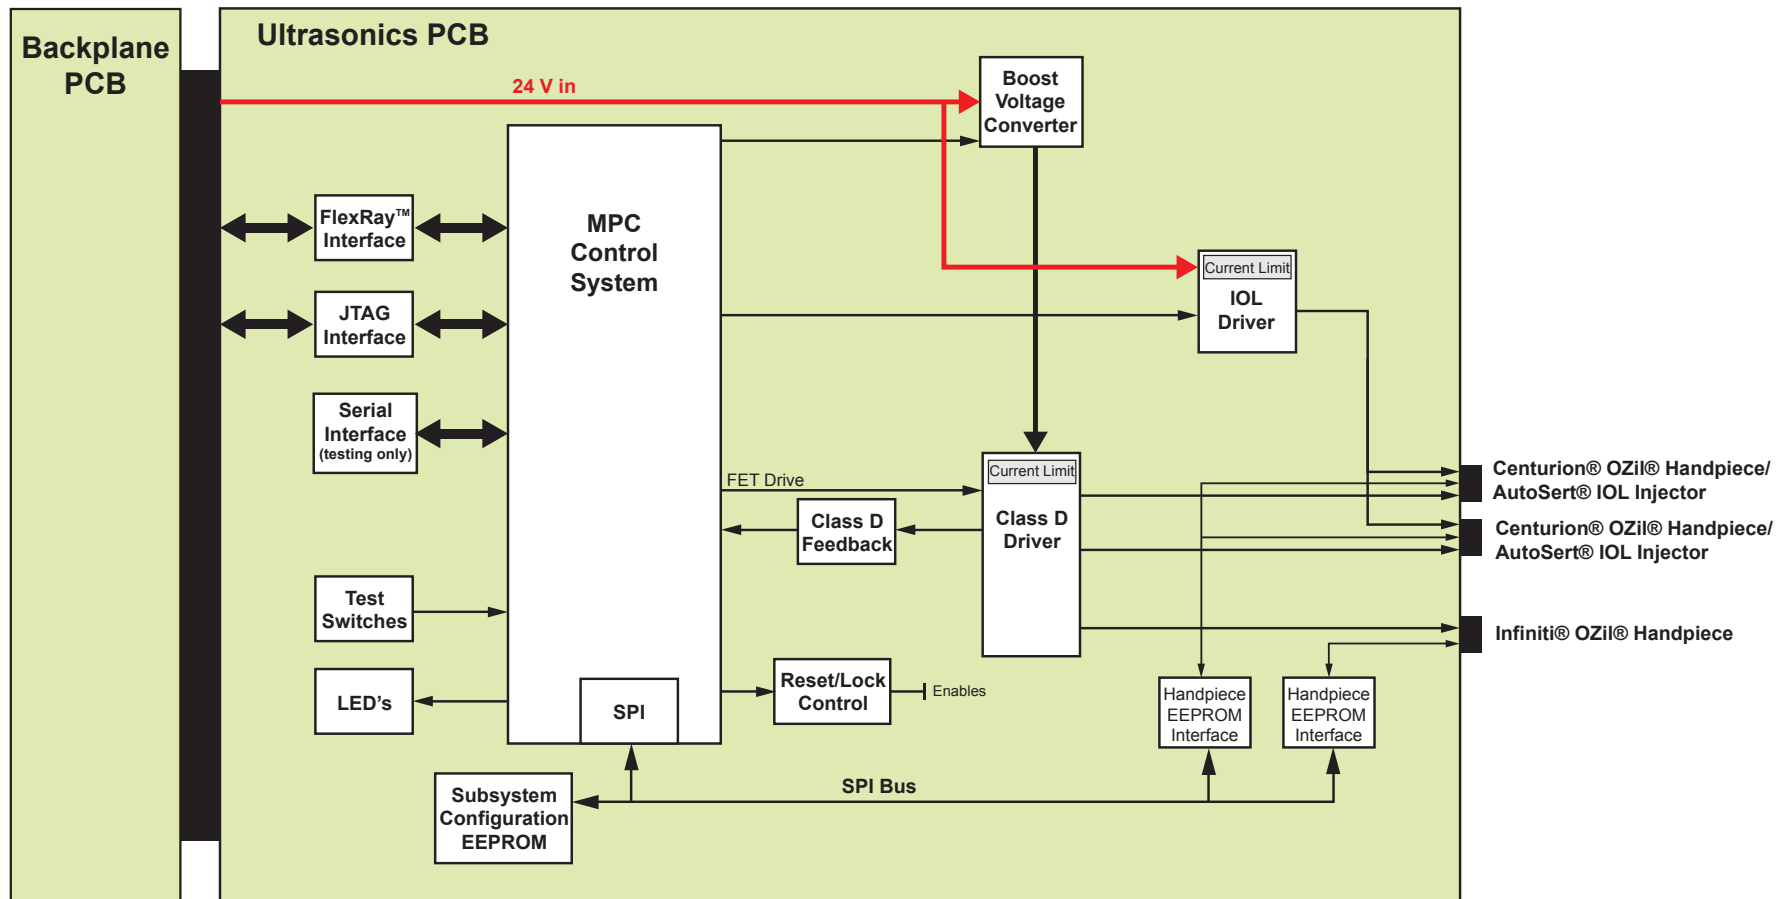
Figure 2-6 Ultrasound PCB Block Diagram

6.3 The Ultrasound PCB block diagram in Figure 2-6 contains the following major circuit blocks:

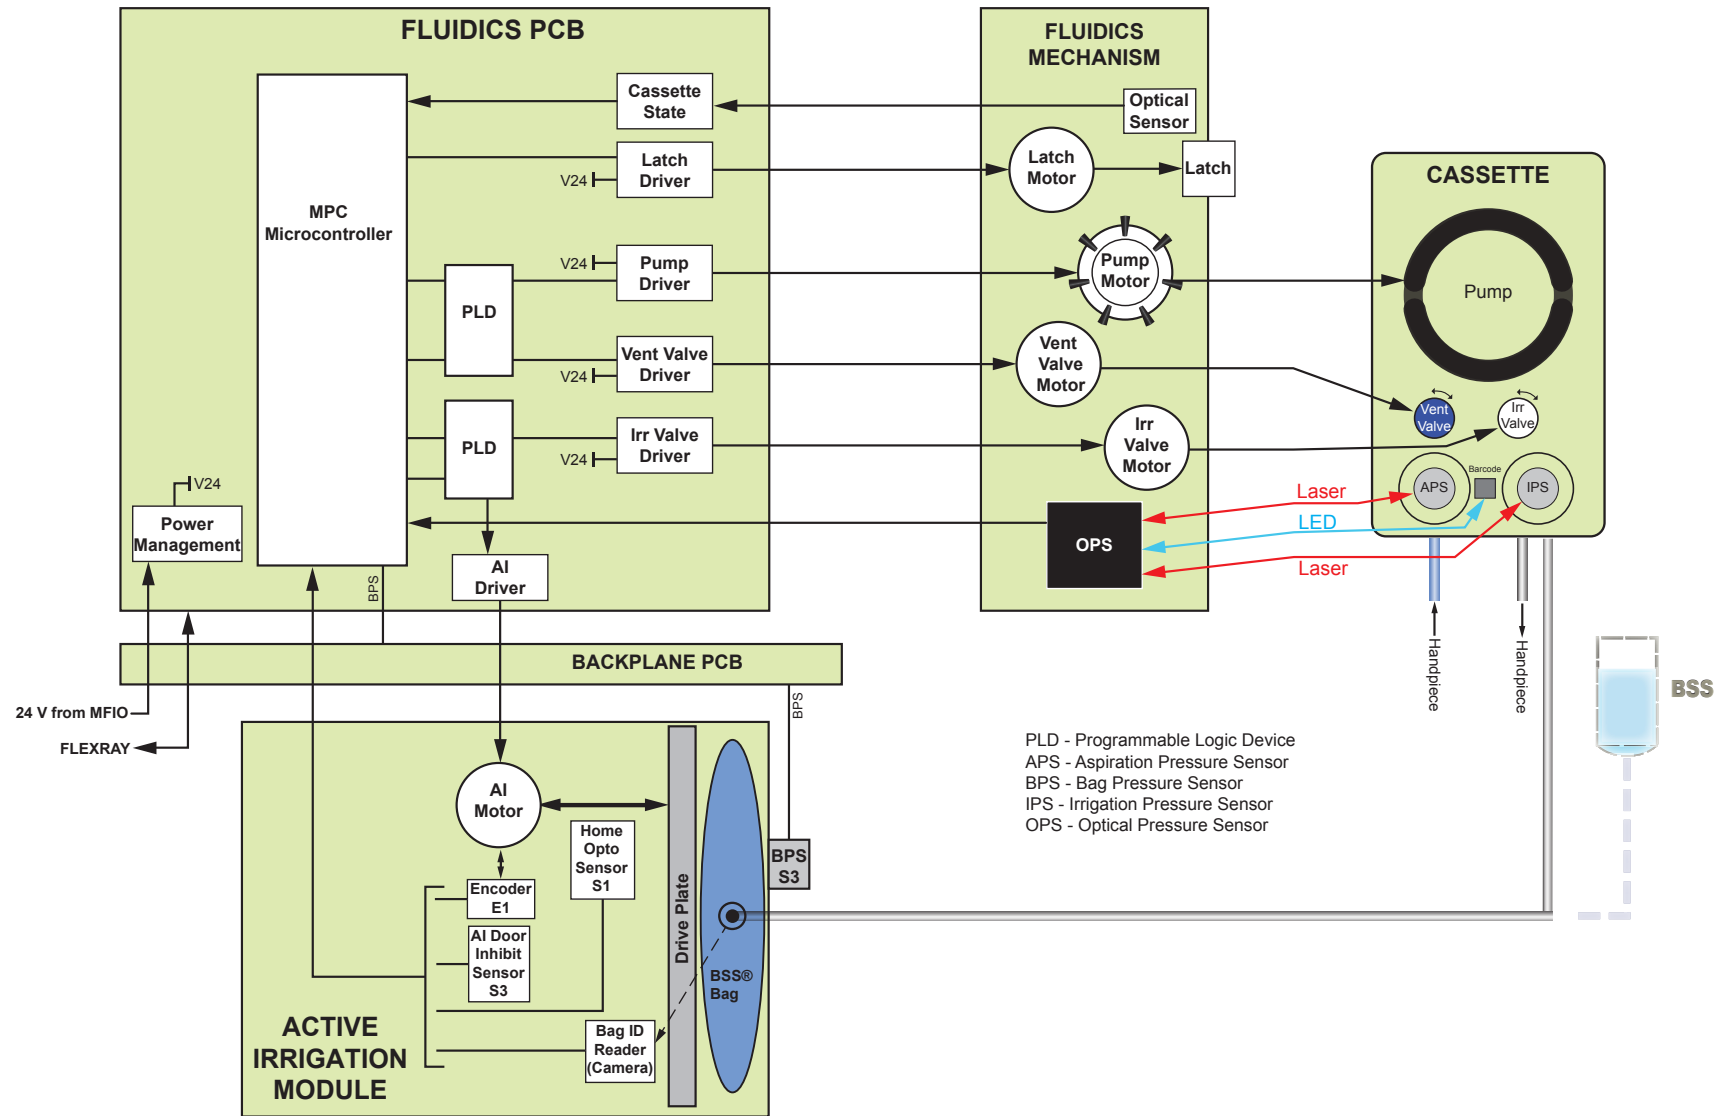
Figure 2-7 Fluidics Block Diagram

- 7.1 There are two primary functions served by the fluidics system during the surgical procedure; one is to aid in the emulsification and removal of cataract lens material, and the other is to maintain a stable work space in which to perform the surgery. A block diagram of the Fluidics System is shown in *Figure 2-7*.

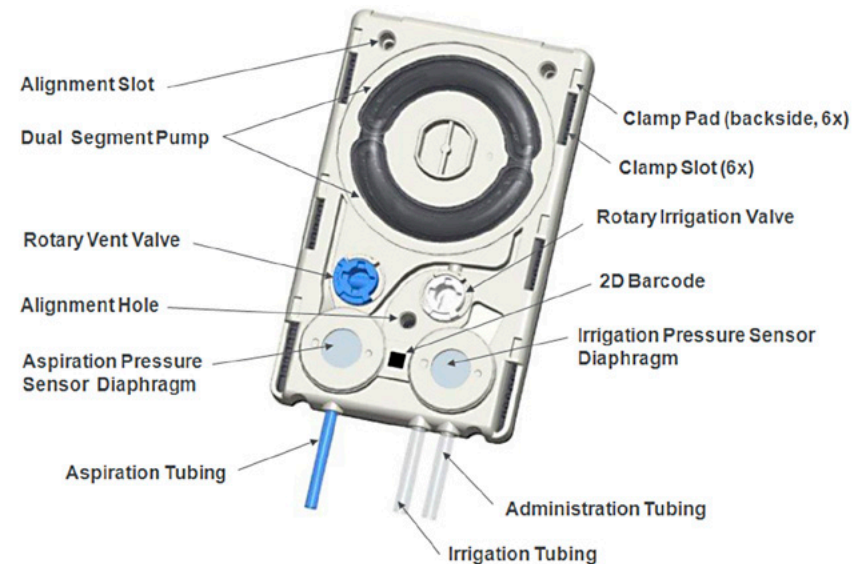
Figure 2-8 Fluidics Management System (FMS)

- 7.5 **Fluid Management System (FMS)** - The Fluidics Management system refers to the consumable cassette that interfaces with the Fluidics Module and provides for routing and control of fluid to and from the eye. All control and sensing functions are non-invasive relative to the sterile patient fluid path. Key components of the FMS are identified in *Figure 2-8*.

- 7.5.1 **Alignment Features** - Alignment of the FMS with the fluidics module is accomplished via an alignment hole and alignment slot in the body of the FMS that engage corresponding alignment pins within the module. This ensures proper interface with controls and sensors once the FMS is drawn into the module and clamped.

- 7.5.2 **Clamping Features** - Clamping tangs from the fluidics module engage the FMS by way of six slots along the edges of the FMS and clamp against pads on the inside of the FMS base.
- 7.5.3 **Administration Line** - The administration line channels fluid from the irrigation source to the FMS. It consists of non-DEHP (Di(2-ethylhexyl) phthalate)) PVC tubing which has .188 inch Outer Diameter (OD) x .125 inch Inner Diameter (ID) (clear, no tint). For Gravity configurations, the tubing is 64 inches long and connected to a spike/drip chamber assembly at the distal end. For Active configurations, the tubing is 30 inches long and connected to a right angled spike at the distal end. The spike provides a shield to facilitate spiking of the bag by a sterile scrub nurse.

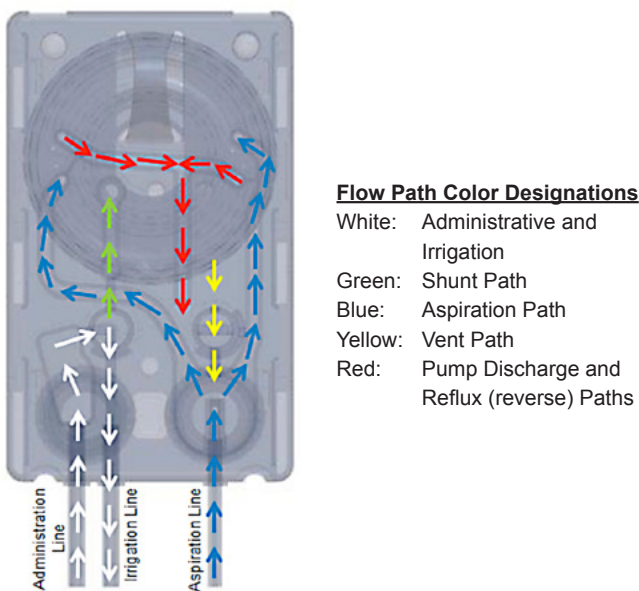
Figure 2-9 FMS Fluid Flow Paths

- 7.5.12 Vent/Reflux Reservoir - This is a liquid reservoir within the FMS assembly that collects a volume of fluid from the discharge side of the pump segments. When the reservoir fills, excess fluid overflows into the drain bag. The reservoir is used as a source of fluid for venting and reflux.
- 7.5.13 Flow Paths - The overall fluid circuit is depicted schematically in [Figure 2-2](#) on page 2.3 while actual flow paths within the FMS assembly are shown in [Figure 2-9](#).

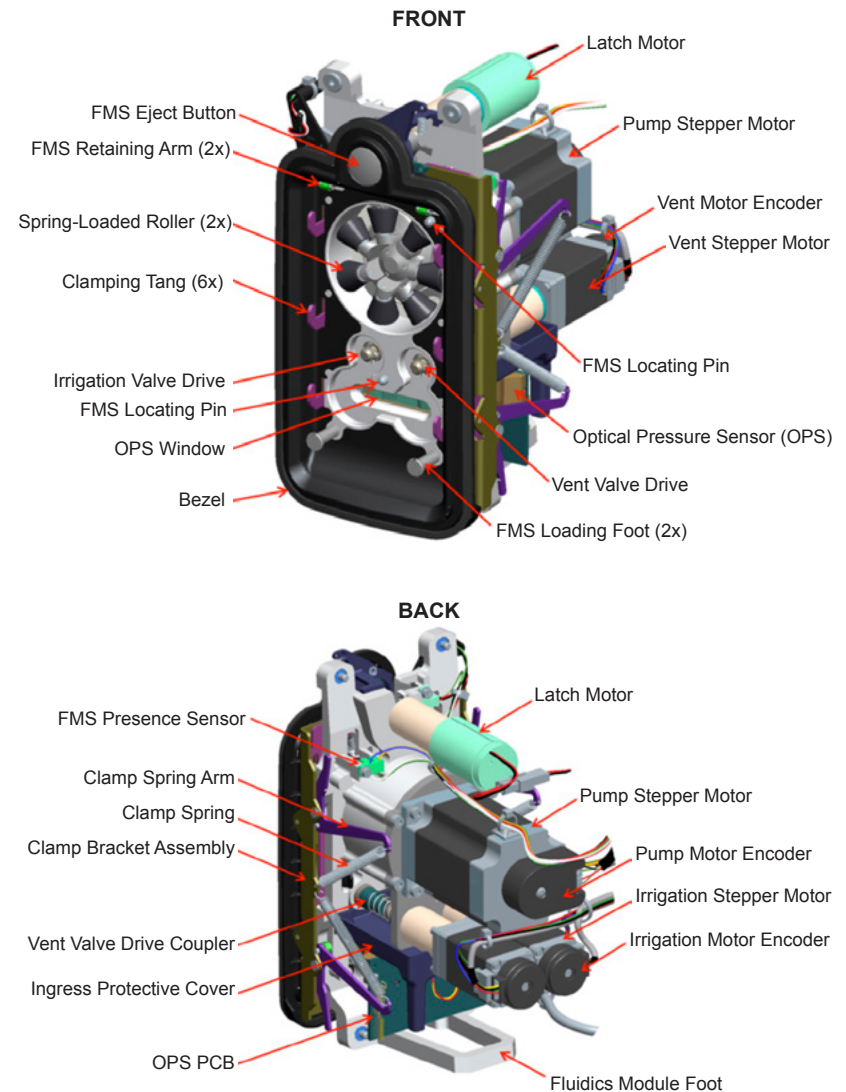
Figure 2-10 Fluidics Module Component Location

- 7.6 **Fluidics Module** - The fluidics module interfaces with the consumable FMS and provides fluidic control functionality. Module components are shown in [Figure 2-10](#).

- 7.6.3 **Rotary Valve Drive** - Stepper motors are used to drive rotary valves for control of irrigation and vent. Valve drives are spring-loaded and are pushed back by the FMS during clamping. After clamping, the valve drives are slowly turned to allow drive bits to drop into corresponding valve plugs. Homing of both valves is accomplished by turning the valves in one direction until a hard stop is encountered (motor skips steps), then reversing direction and verifying a second hard stop the correct number of steps away.

- 7.6.4 Optical Pressure Sensor (OPS) - The optical pressure sensor assembly measures displacement of both irrigation and aspiration pressure sensor diaphragms. A beam of light from a laser is reflected off the diaphragm and back to a photo detector within the OPS assembly. Deflection of the diaphragm causes the reflected light to strike the detector at different locations. The system is calibrated to correlate position of the reflected beam with pressure acting on the diaphragm.
- 7.6.5 Eject Button - The eject button triggers a photo interrupt sensor resulting in unclamping of the FMS. Under normal power conditions the system will close both valves prior to unlatching. This minimizes leakage of liquid from the FMS during removal and disposal.
- 7.6.6 Fluidics PCB - Electronics controlling fluidics module functions are located on the Fluidics PCB.

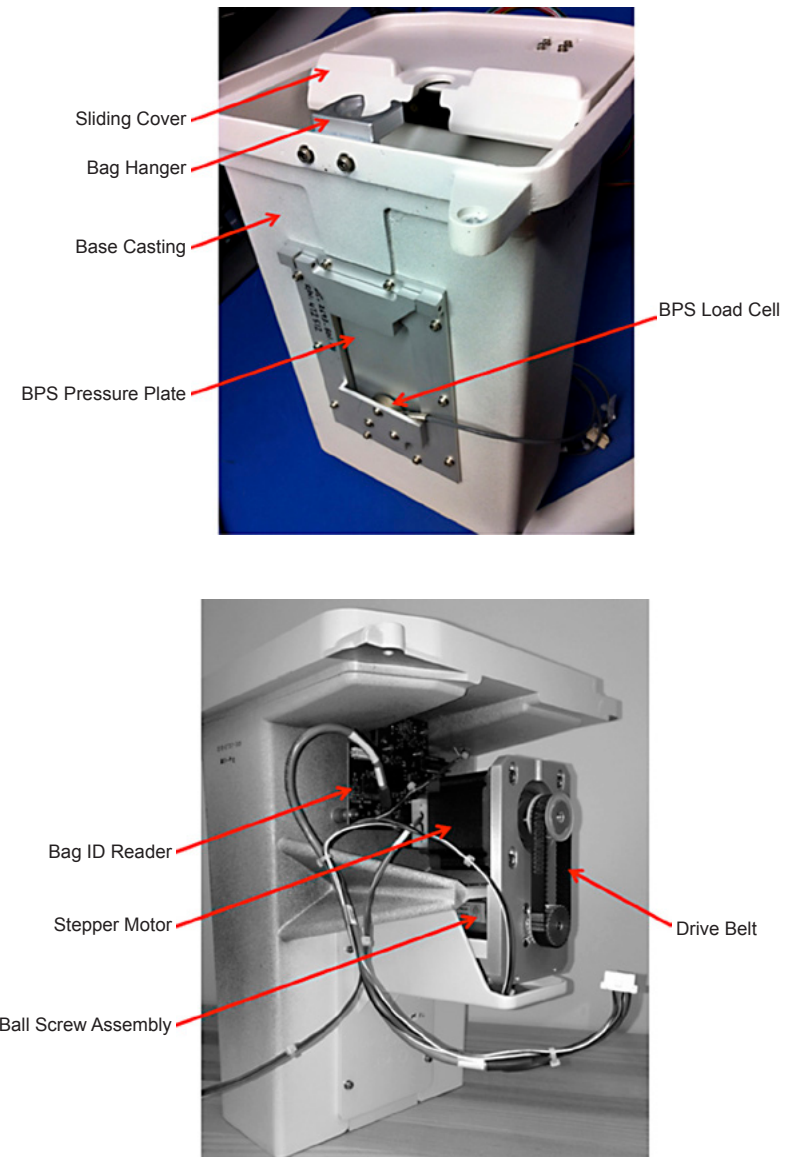
Figure 2-11 Active Irrigation (AI) Module Component Location

7.7.1 The active irrigation module compresses a flexible bag of irrigation solution between a stationary plate and a stepper motor controlled push plate to create and control pressure delivered to the surgical site. Module components are shown in *Figure 2-11*.

7.7.2 Base Casting - The AI base casting is a single piece aluminum casting that serves as a receptacle for the irrigation bag and a means of containment of liquid in the event of leakage from the bag. Duct work directs any leakage to the outside of the console. The wall of the base casting opposite the push plate serves as the stationary compression plate.

7.7.5 Push Plate & Drive Assembly - The push plate is used to compress the irrigation bag against a stationary wall of the AI base casting. The push plate is mounted to a linear ball screw assembly that is controlled via a stepper motor. A belt drive system is used to transfer torque from the motor to the linear ball screw assembly. An encoder attached to the back of the stepper motor is used to ensure that commanded rotation corresponds to actual rotation. When the push plate is retracted, a photo interrupt switch is used to establish home position.

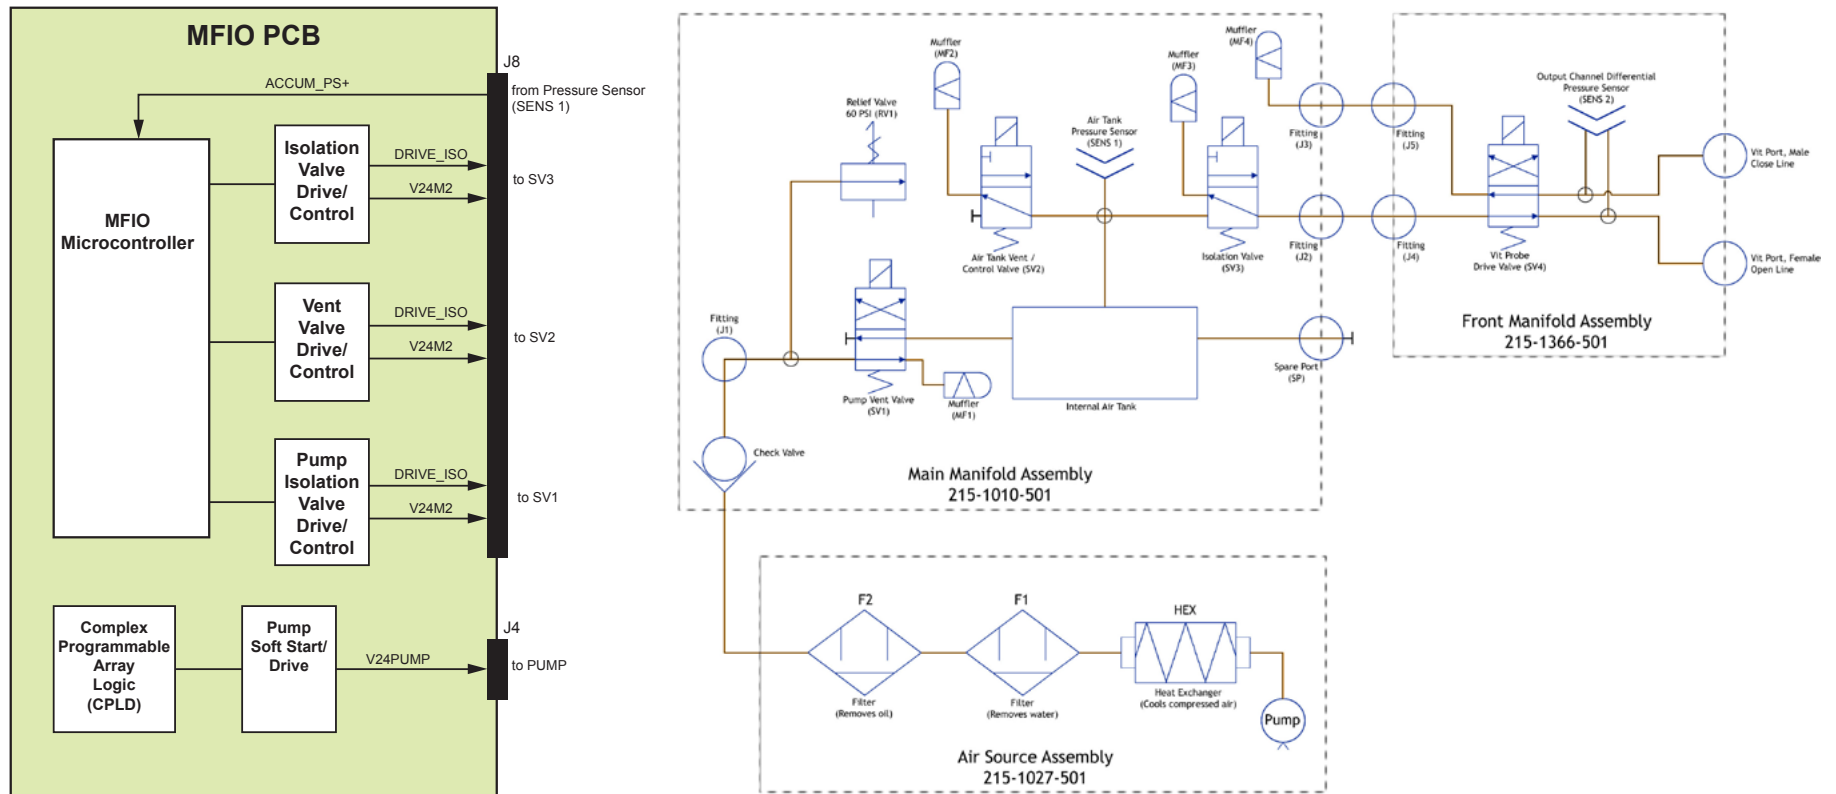
Figure 2-12 Pneumatic Block Diagram

8. PNEUMATICS (see *Figure 2-12*)

- The two Output Fittings (J6 and J7) are made of metal. Their sleeves are made of black and clear anodized (silver color) aluminum. The size of the opening of these two fittings are different and both fittings are female type. Therefore, the connection of the two Centurion UltraVit probe connectors are not interchangeable and it is incompatible with any other Vitrectomy probe.

- The exhaust line of the Front Manifold assembly is connected to Muffler (MF4) on Main Manifold assembly. This is for noise suppression and is tuned for specific back up pressure which is important for performance of the system.

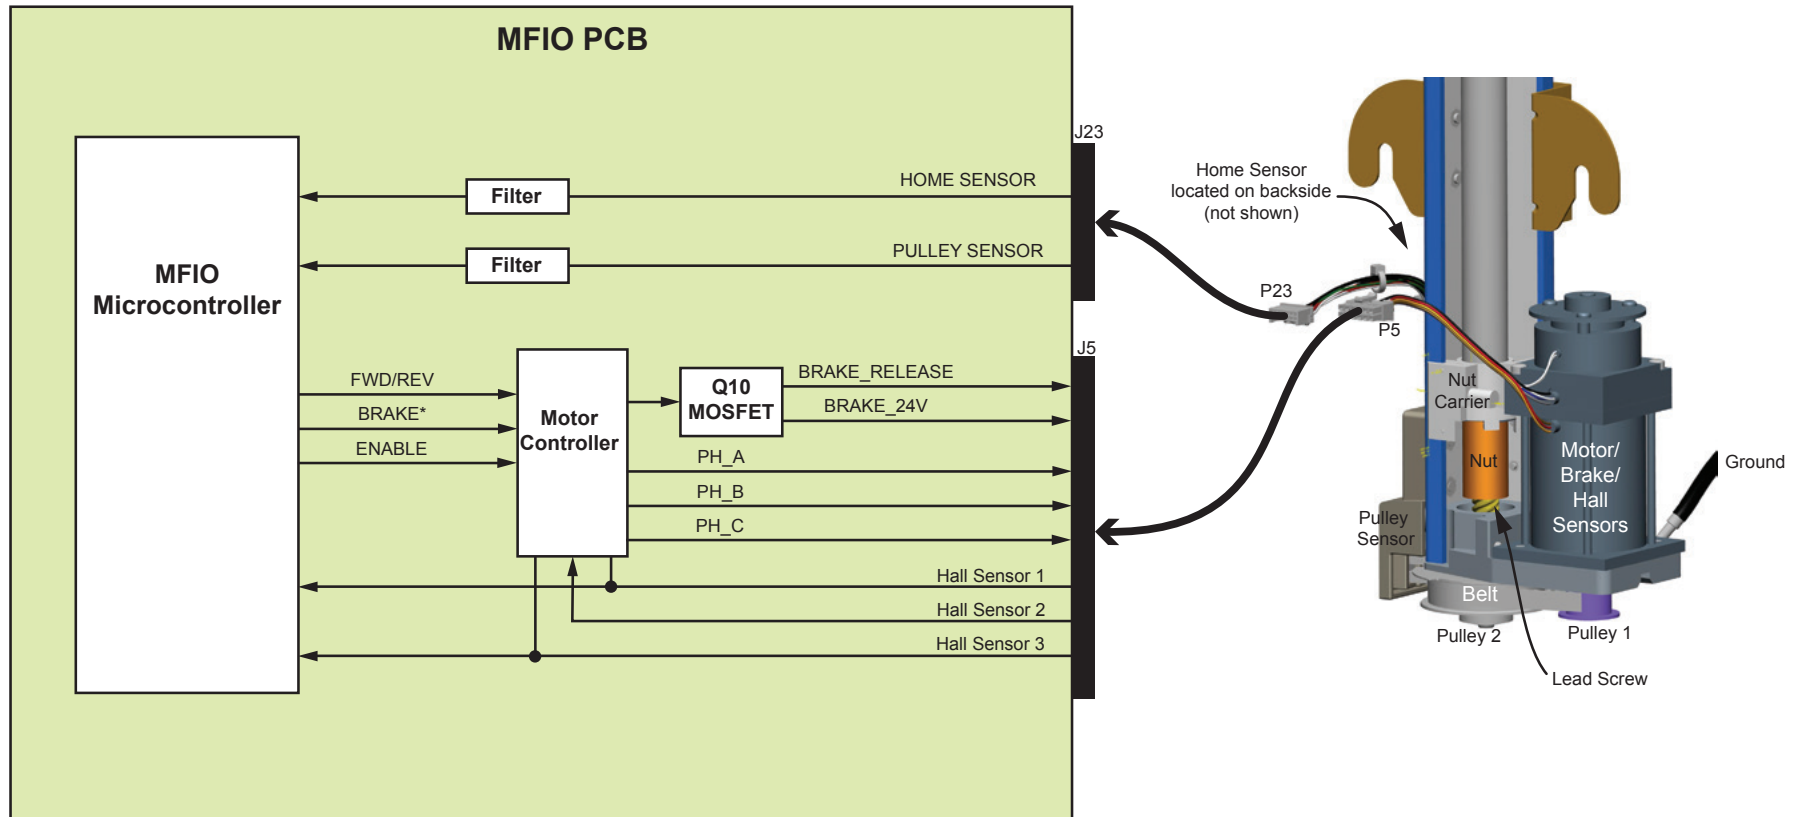
Figure 2-14 IV Pole Block Diagram

10. IV POLE (see *Figure 2-14*)

- 10.9 Lead Screw rotation is converted into vertical linear translation by the Nut. Rotation of the Nut is prevented by housing the Nut in the Nut Carrier. The Nut Carrier is constrained from rotating and slides along the base as the nut translates. Vertical translation of the Nut and Nut Carrier is imparted to the pole by interfacing the pole to the Nut Carrier.

- 10.10 The Home position, or lowest position, of the pole is established by a Sensor Flag that is attached to the Nut Carrier. The Sensor Flag interacts with a Home Sensor which is in communication with the MFIO PCB.

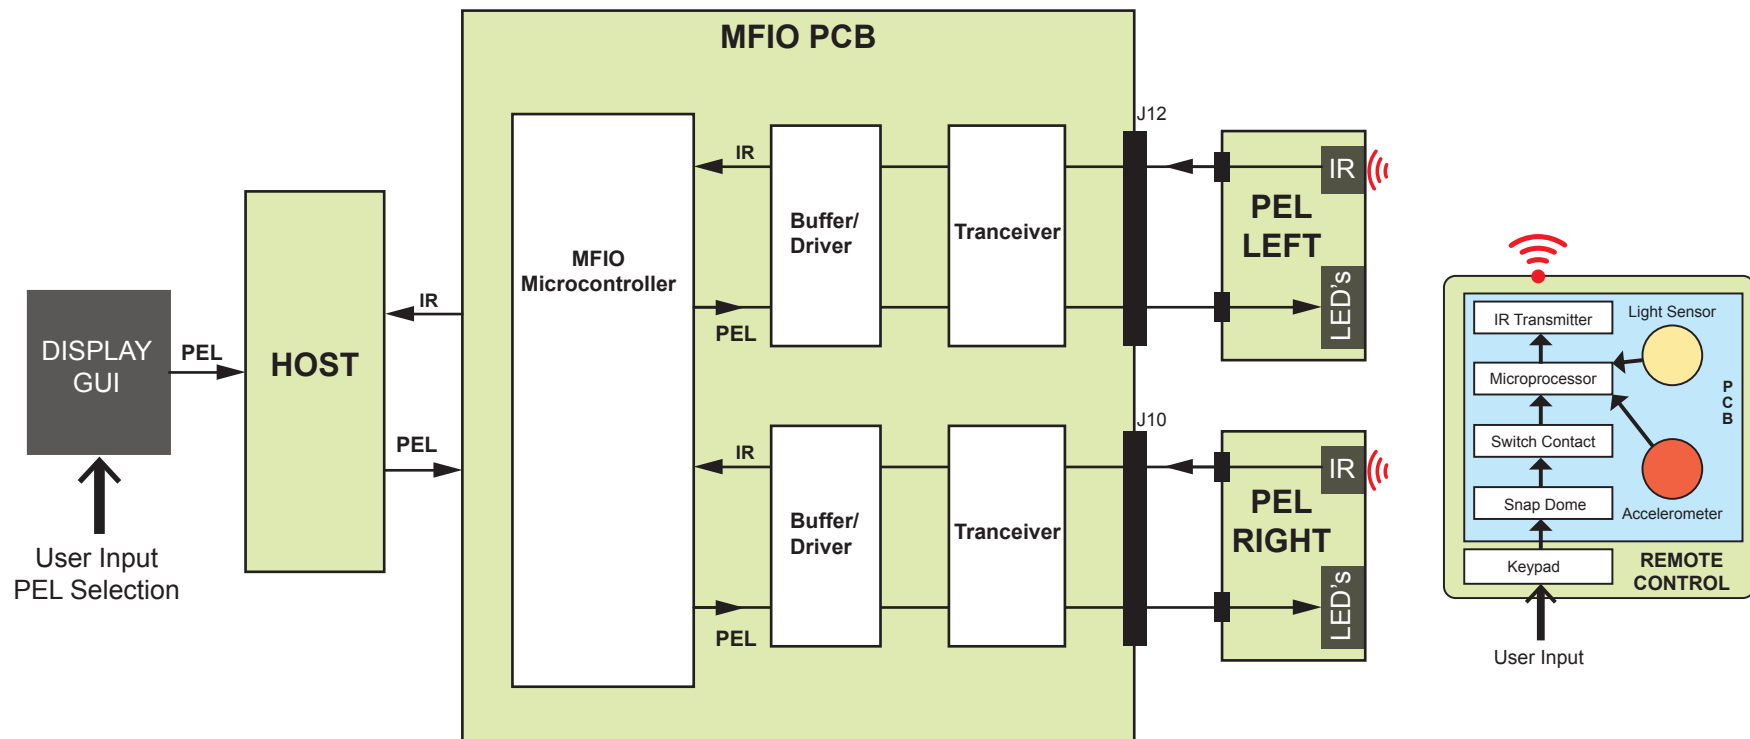
Figure 2-15 PEL Panel / Remote Control Block Diagram

11. PEL (PATIENT EYE LEVEL) PANEL (see *Figure 2-15*)

- 11.1 The PEL Panel provides visual feedback for the current PEL setting on the system. The primary components of the PEL Panel consist of a PCB that houses the functional electronics, and molded plastic components that embody the assembly. Left and Right PEL Panels are symmetric and are assembled on either side of the console. Figure 2-11 a block diagram of the PEL interface with the system.

12. REMOTE CONTROL (INFRARED) (see *Figure 2-15*)

- 12.5 **SIGNAL PROCESSING** - When a signal arrives from one of the keypad circuits, the microprocessor receives the signal and uses the software algorithm stored in the flash RAM to send a unique coded signal to the IR Transmitters mounted on the front edge of the PCB.

- 12.6 **IR TRANSMISSION** - The IR Transmitting LED's emit an infrared digital code that is unique for each key depression. This signal passes through the IR-transparent material of the front housing and is received and processed by the console.

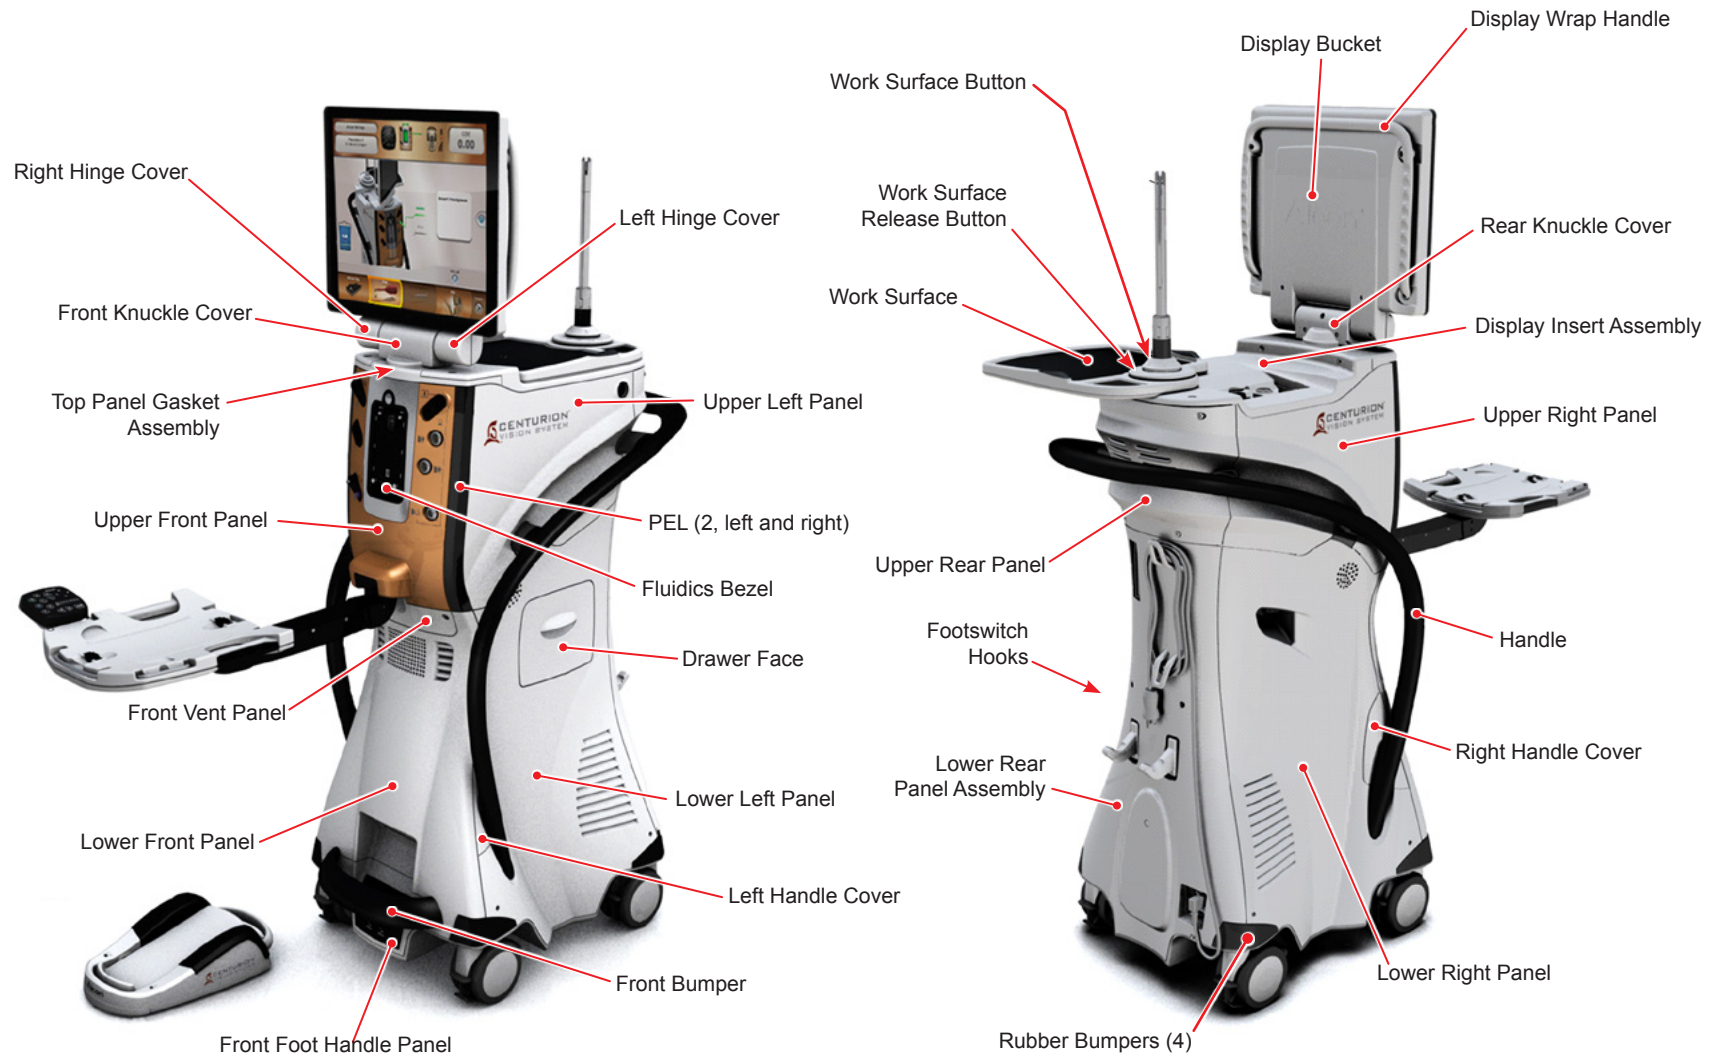
Figure 3-1 Outer Panel Location Diagram

OUTER PANEL LOCATIONS - See *Figure 3-1*.

- Left and right orientation is referred to from the console perspective
- Replacement is performed in reverse order of disassembly unless noted otherwise.
- Refer to [Figure 3-1](#) and [Figure 3-2](#) for component location.

REMOVAL OF OUTER PANELS (see [Figure 3-1](#))

The outer panels are designed so that each upper panel extends over the panel below it, and the rear panel extends over the side panels. Therefore, when removing the outer panels, the general rule is that an upper panel must be removed in order to remove a lower panel. Additionally, the rear panel must be removed in order to remove a side panel. In some cases, panel access may be allowed by simply loosening the screws securing the panel above it. The following instructions will enable disassembly in a timely yet safe manner.
